# Navajo Abandoned Uranium Mine Site Screen Report

## **Christensen AUM Site**

## **Navajo AUM Eastern Region**

**May 2009**

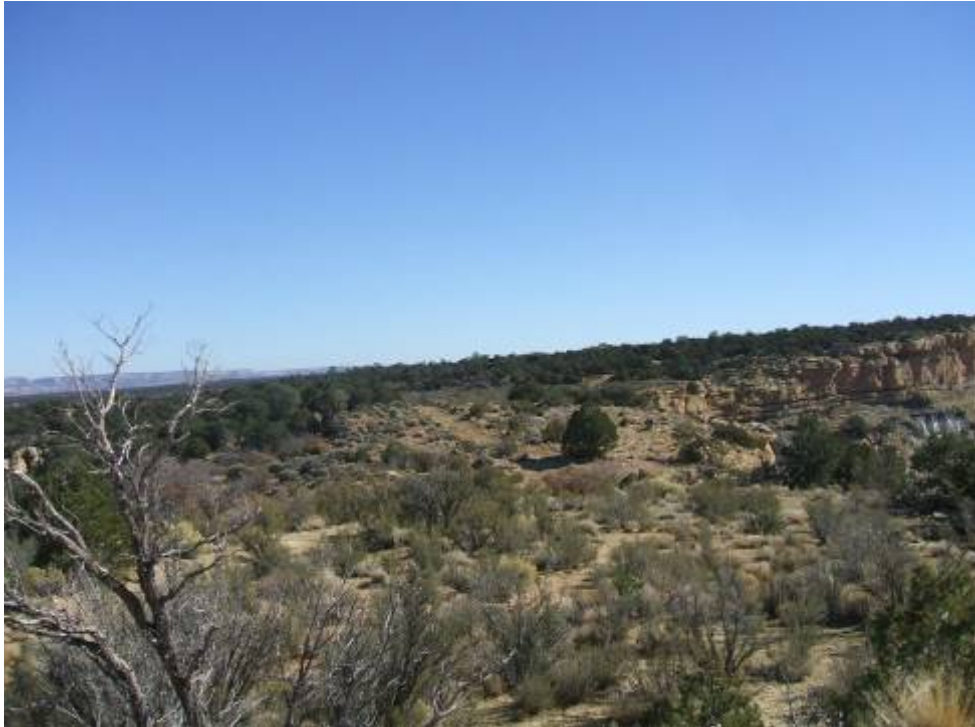
Photo 1. Mine site, from background location, towards the northeast

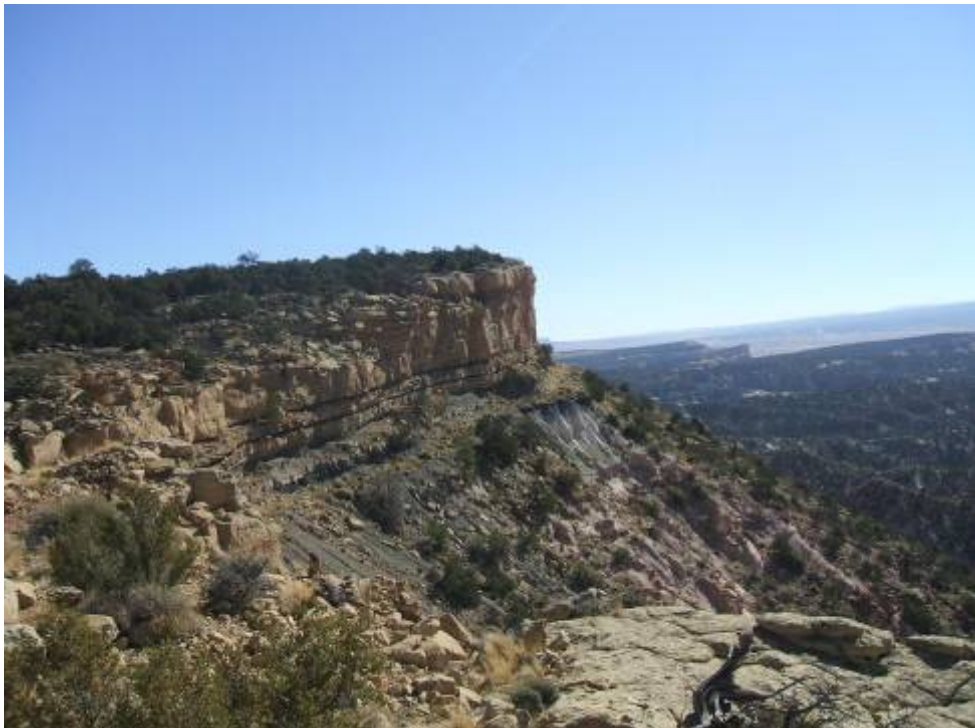
Photo 2. Mine site cliff area, towards the east/northeast

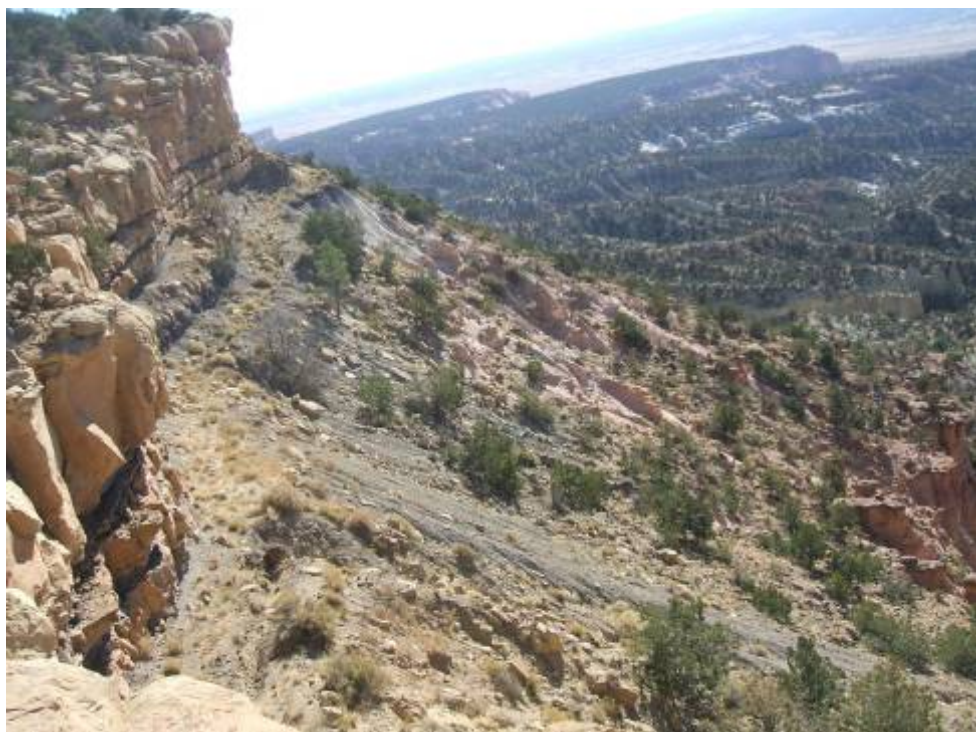
Photo 3. Mine site and cliff face area, towards the east

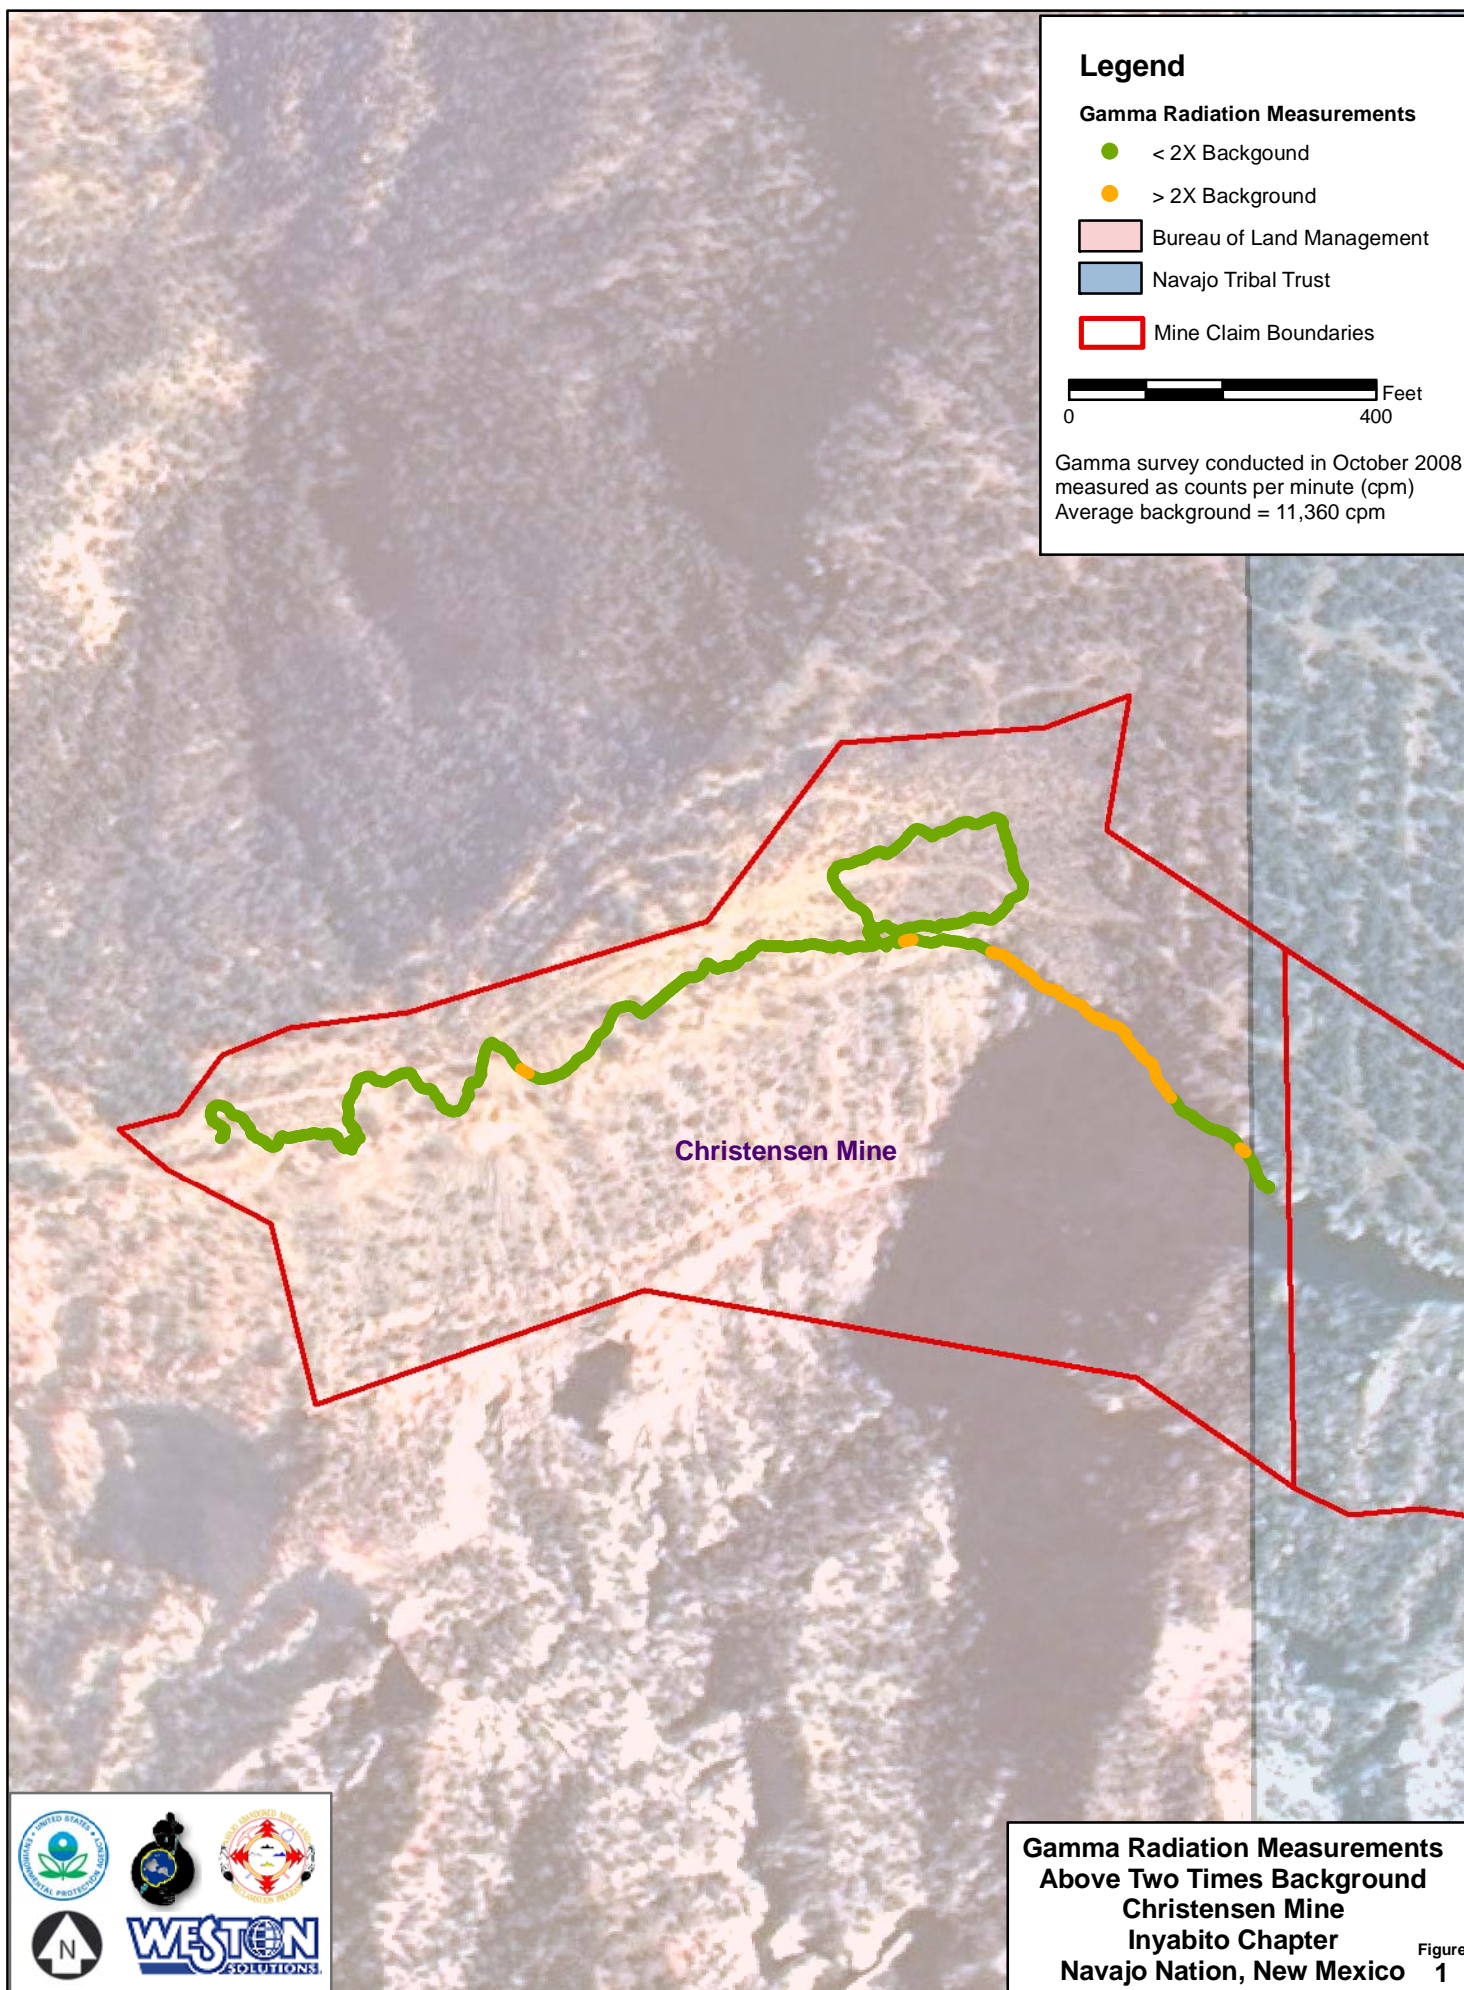
Figure  
2

A total of 949 gamma radiation measurements were collected from mine sites, ranging from 7,342 cpm to 105,360 cpm. The measurements are represented in Figures 1 and 2.

Gamma Radiation Measurements  
Christensen Mine  
Inyabito Chapter  
Navajo Nation, New Mexico
